## Gary Court - commercial case study

### The plant room at Gary Court houses two boilers; one mains boiler and one Binder 149kW wood pellet boiler.

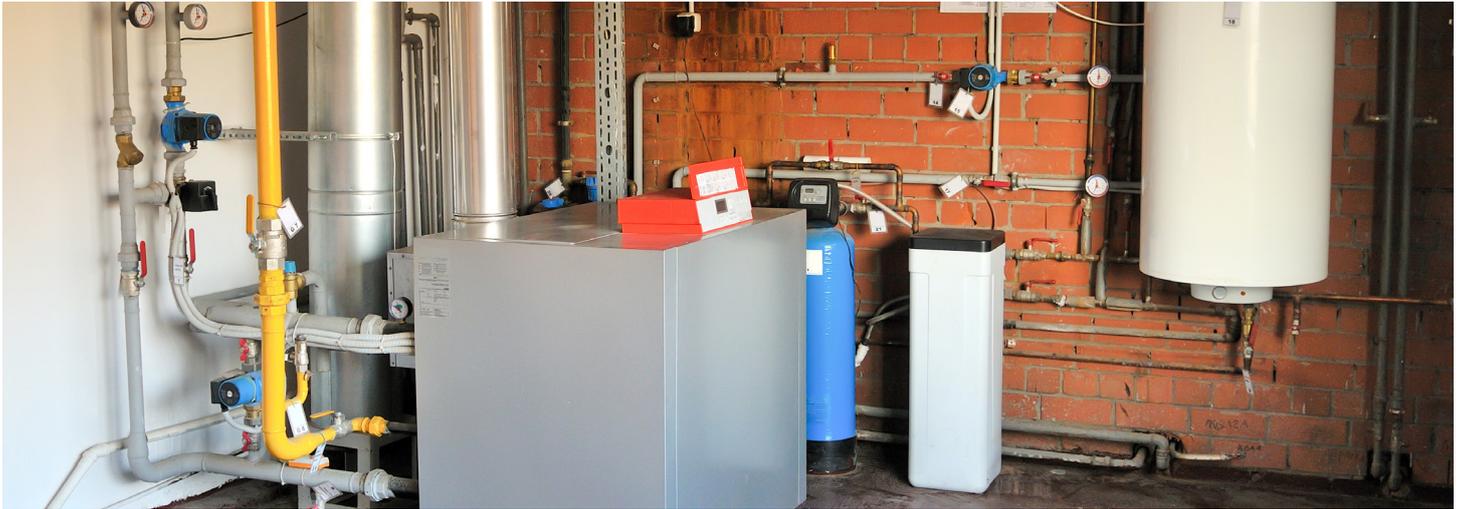
A complete Binder boiler inspection was conducted, identifying the following:

1. The grate had collapsed with the grate teeth lying on the ash receiver floor.
2. The frame of the grate had disintegrated due to what appeared to be severe overheating.
3. The combustion chamber firebricks were cracked and dislodged. Evidence of severe overheating or prolonged very high temperatures.
4. The heat exchanger was clogged and covered in flue ash and soot. This is evidence that either no or very little maintenance was ever carried out.
5. The system appears to have been installed without a Back End Protection circuit or BEP. The BEP ensures the boiler circulates water around the water jacket to raise the boiler to operating temperature quickly, before opening a three port valve to allow the main circuit to be heated. The damage caused to the boiler is due to excessive and prolonged periods of high temperatures.

An oil-filled boiler was installed as a temporary measure. It was regularly monitored by VHL engineers and topped up to ensure no disruption in services and resident satisfaction.

A gas boiler present at the property was fixed, which provides the heat on a temporary basis. The client was made aware that the gas boiler, although sufficient in the summer, would not be adequate for coping with demands in the winter and a permanent refit would need to be done.

A quotation was provided to replace the biomass boiler as per the recommendation.
